PART F

MICROCRATER INVESTIGATIONS ON SURVEYOR 3 MATERIAL

E. Schneider, G. Neukum, A. Mehl, and H. Fechtig

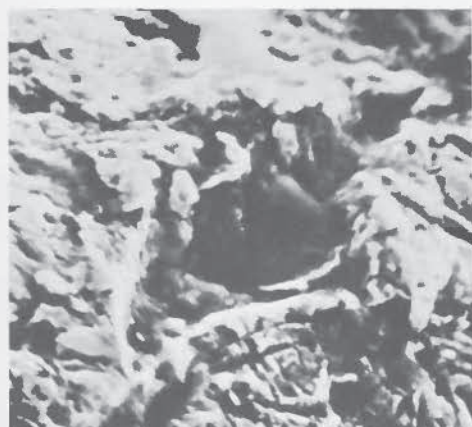
The original surfaces of the screws and washers were not specially prepared in any way for scientific investigations. They are rough and probably inadequate to yield reliable results. On screw 2¹ (see fig. 3), strange features could be observed. Figure 4 shows six interesting objects on screw 1; these objects can be considered as impact phenomena.

FIGURE 3.—Stereoscan photographs of objects found on the surface of screw 2 (probably not microcraters).

The crater objects found on the screws can be compared with artificially produced micrometer-sized impact craters on metal targets. Rudolph (ref. 3) has published photographs of microcraters produced in the laboratory using a 2-MV Van de Graaff dust accelerator. Figure 5 shows some craters produced by impacts of iron projectiles on various metal targets with an impact velocity of 5.2 km/sec. The six objects on screw 1 (shown in fig. 4) appear to be low-velocity impact craters ($\leq 5\text{ km/sec}$). They may have been produced either by interplanetary dust particle impacts or by secondary lunar debris from larger impacts on the lunar surface. The three objects on the surface of screw 2 (fig. 3), however, are considered to be manufacturing artifacts rather than impact craters.

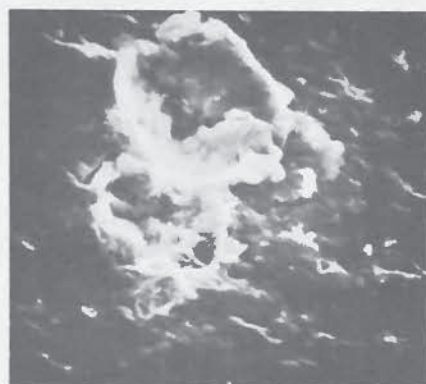
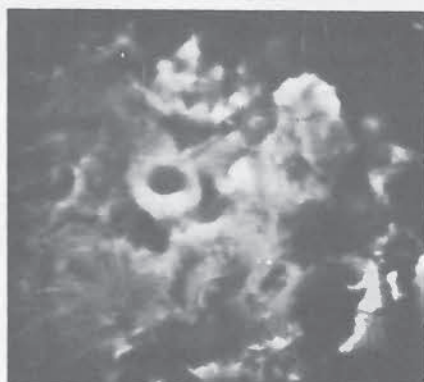
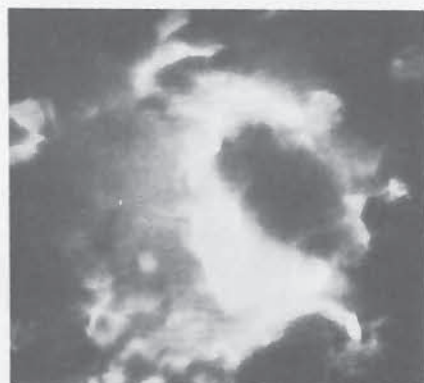
FIGURE 4.—Stereoscan photographs of objects on screw 1; most of the objects are assumed to be microcraters.

Assuming that the six craters on one of the screws are a result of primary impacts, it is possible to calculate a flux, Φ , for the 31-month exposure time and the surface area of about 0.12 cm^2 :

With the data involved in these investigations, one obtains a flux of $\Phi = 5 \times 10^{-3} \text{ m}^{-2} \text{sec}^{-1}$.
